# Manhole Inspection Summary

Manhole # S43W\_\_001MH

Insp Date: **2/29/08 7:49 AM**

**Location** Address: **rear 1411 hull st.**

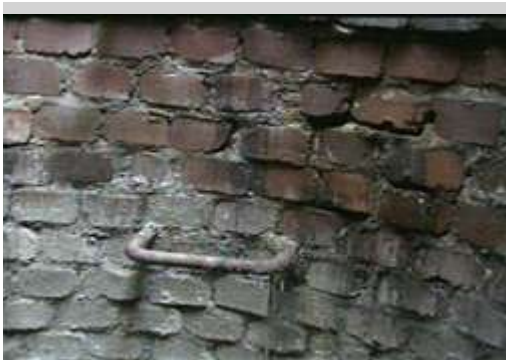
Defect 5

**Steps** Count: **4** Missing: **0** ☒ **Corroded**

**Surcharge** ☒ **Evidence Of Surcharge** Depth: **2** (ft.) ☐ Active Surcharge Present

surcharge debris, corroded steps

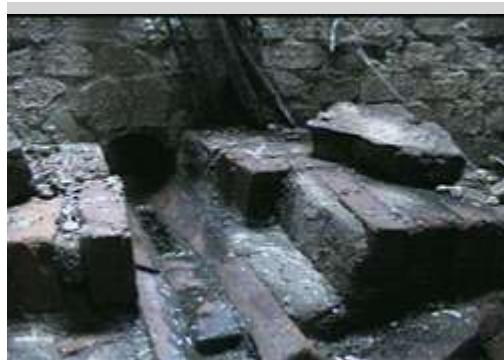
Defect 4

Condition: ☐ Sound ☐ Cracked ☐ Root Intrusion ☒ **Deteriorated** ☐ Leaks ☐ Debris

channel deteriorated

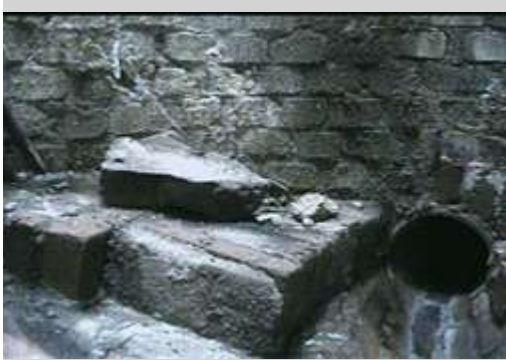
Defect 3

Condition: ☐ Sound ☐ Cracked ☐ Root Intrusion ☒ **Deteriorated** ☐ Leaks ☒ **Debris**

bench deteriorated & debris

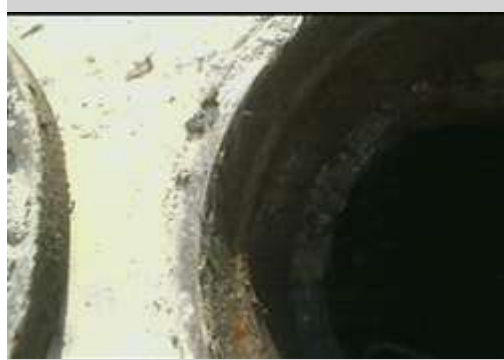
Defect 2

**Frame** Offset: **1** (in.) Condition: ☒ Sound ☐ Cracked ☐ Leaks

offset defect

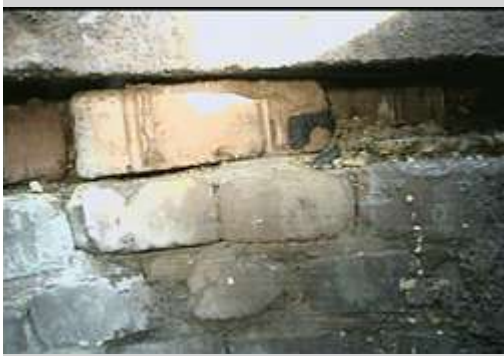
### Defect 1

Condition: ☐ Sound ☐ Cracked ☐ Root Intrusion ☒ **Loose Brick** ☐ Deteriorated

loose bricks in chimney

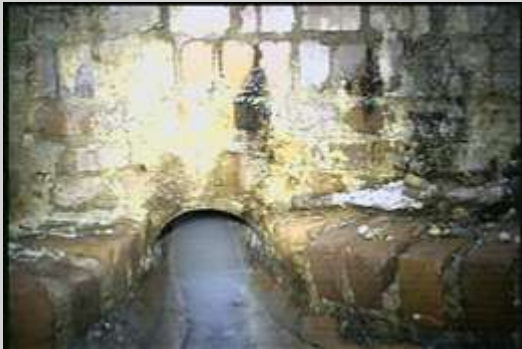
12 O'Clock Outflow

8 in. Circular Gravity Sewer  
Pipe Out @ 12 O'Clock

Invert Depth: **9.20** (ft.) Flow Characteristics: **Slow**

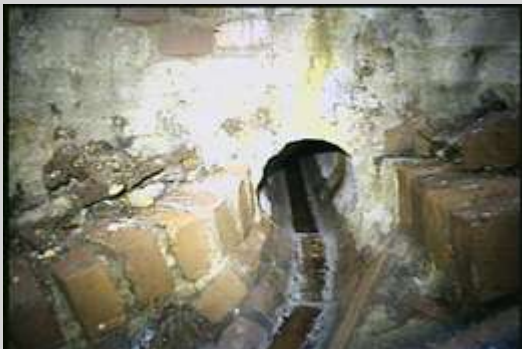
3 O'Clock Inflow

6 in. Circular Gravity Sewer  
Pipe In @ 3 O'Clock

Invert Depth: **9.00** (ft.) Flow Characteristics: **Fast**

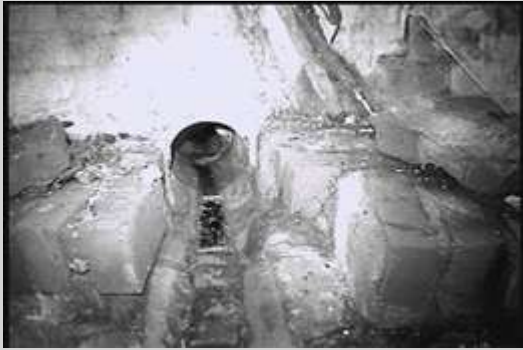
6 O'Clock Inflow

6 in. Circular Gravity Sewer

Pipe In @ 6 O'Clock

Invert Depth: **8.70** (ft.) Flow Characteristics: **None**

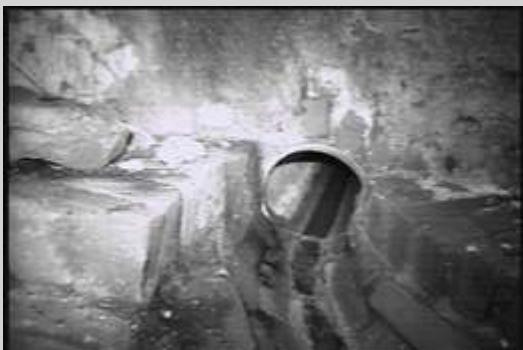
9 O'Clock Inflow

8 in. Circular Gravity Sewer

Pipe In @ 9 O'Clock

Invert Depth: **9.10** (ft.) Flow Characteristics: **Fast**
